# Security Incident Report

**DEMO-0001**  
Illustrative dates and identities  
Map location: GMS office

The incident occurred whilst we were working on behalf of Example Estates Ltd, at a site known to us as Demonstration Commercial Premises.

Unit 5 Evtol Trading Estate  
Frederick Street  
Newport  
NP20 2DR

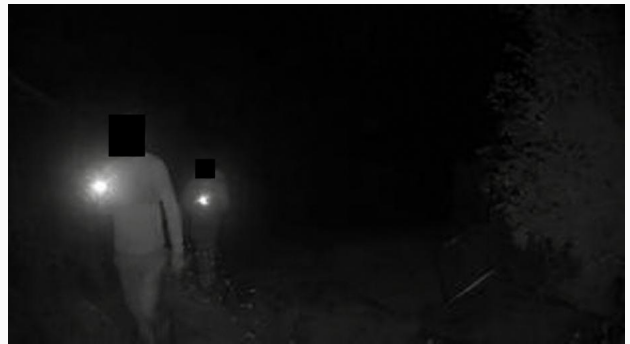
**Captured 10/09/2026 22:17**

Illustrative perimeter detector view. Edited for this public sample; faces obscured.

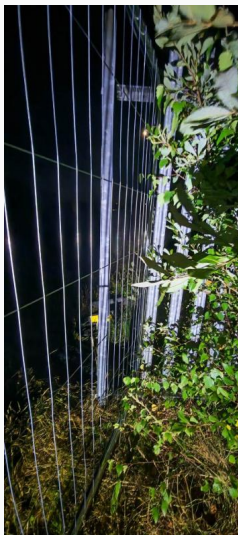
**Captured 10/09/2026 23:55**

Temporary securing of a fence junction. Neutral caption and illustrative capture time.

Site inspection and action: damage was found at a pedestrian gate and at a fence junction. The officer secured both openings using temporary fixings. The equipment enclosure was also checked for signs of interference. Permanent repairs were recommended for the client's follow-up.

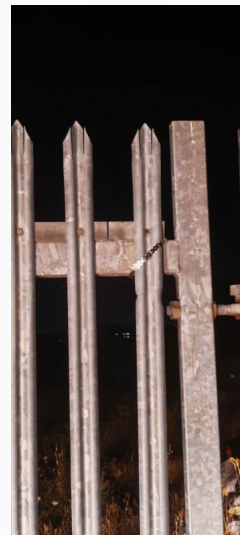
**Captured 10/09/2026 23:57**

Temporary repair to a gate opening. Neutral caption and illustrative capture time.
